SERVICE BULLETIN 176E

SUBJECT: Necessary Actions Following Object Strike of Stationary Propeller, Blade Strike of Rotating Propeller, Bird Strike, or Sudden Engine Stoppage

MODELS AFFECTED: All McCauley Propellers

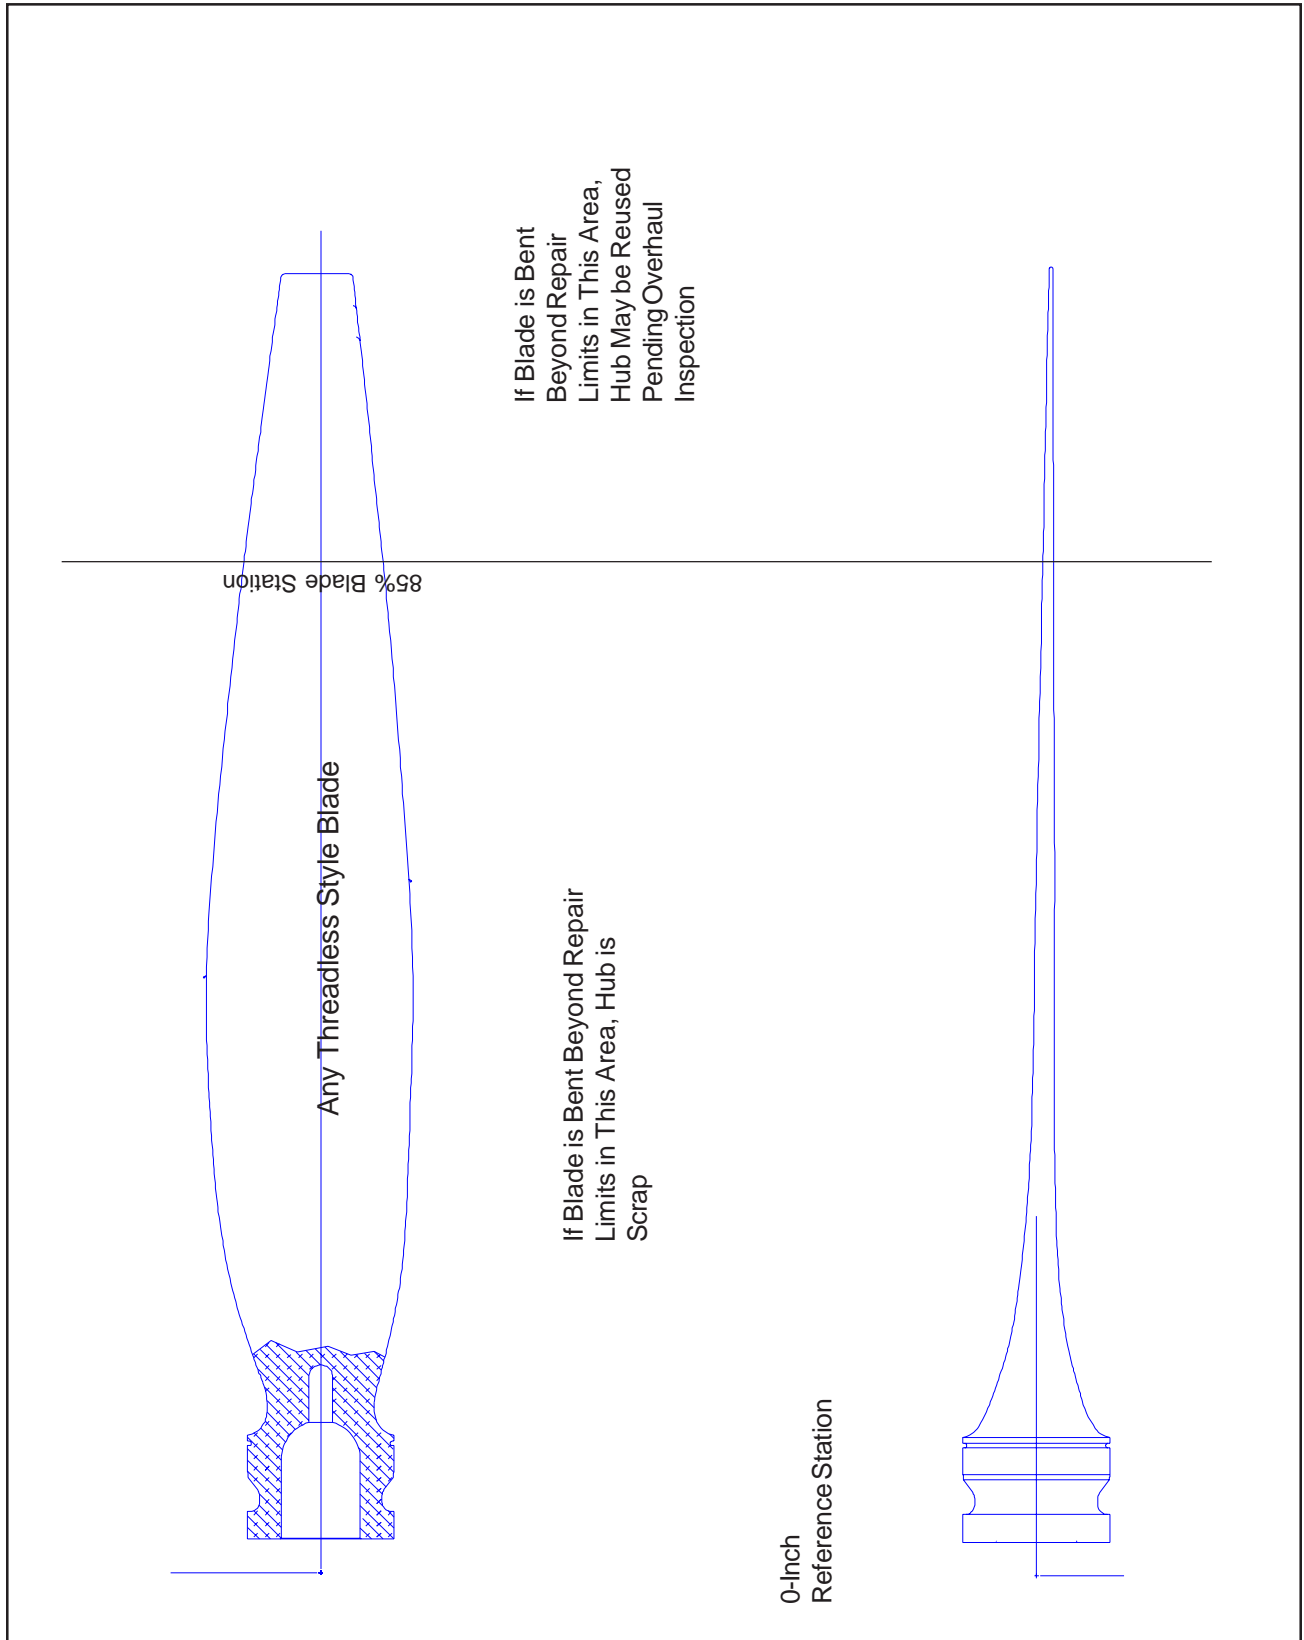
A hub must be declared unairworthy and scrapped if any blade in the propeller assembly is bent beyond repair limits within the first 85% of total blade station radius (Refer to Figure 1 and 2). A hub may be returned to service, pending normal overhaul inspection, if any blade in the propeller assembly is bent beyond repair limits outboard of the 85% blade station radius.
