# SERVICE BULLETIN 176E

**SUBJECT:** Necessary Actions Following Object Strike of Stationary Propeller, Blade Strike of Rotating Propeller, Bird Strike, or Sudden Engine Stoppage

**MODELS AFFECTED:** All McCauley Propellers

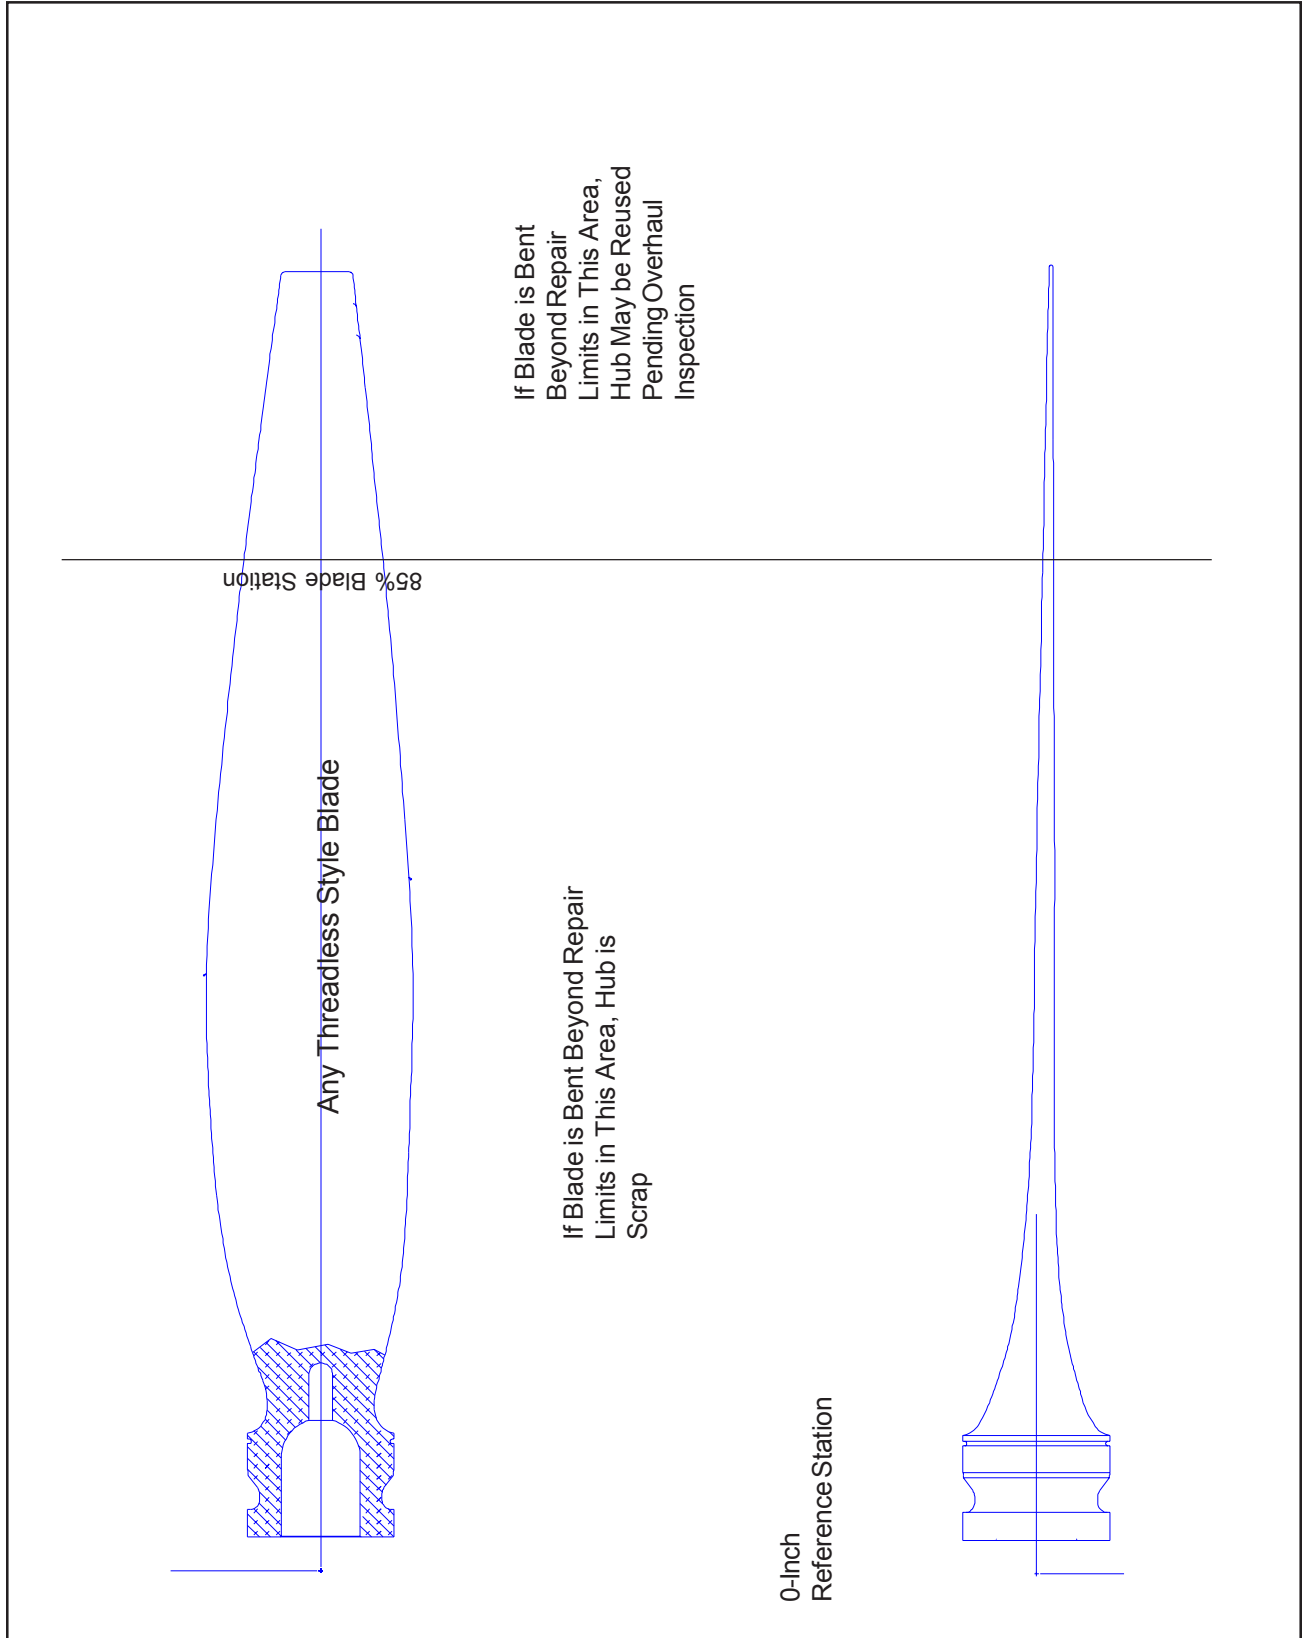
A hub must be declared unairworthy and scrapped if any blade in the propeller assembly is bent beyond repair limits within the first 85% of total blade station radius (Refer to Figure 1 and 2). A hub may be returned to service, pending normal overhaul inspection, if any blade in the propeller assembly is bent beyond repair limits outboard of the 85% blade station radius.
